New York State Department of Transportation

Yellow Flag NB23U4W007

BIN: 1065318

Location: Span 110, Stringer S1 at 3rd Transfer Beam.

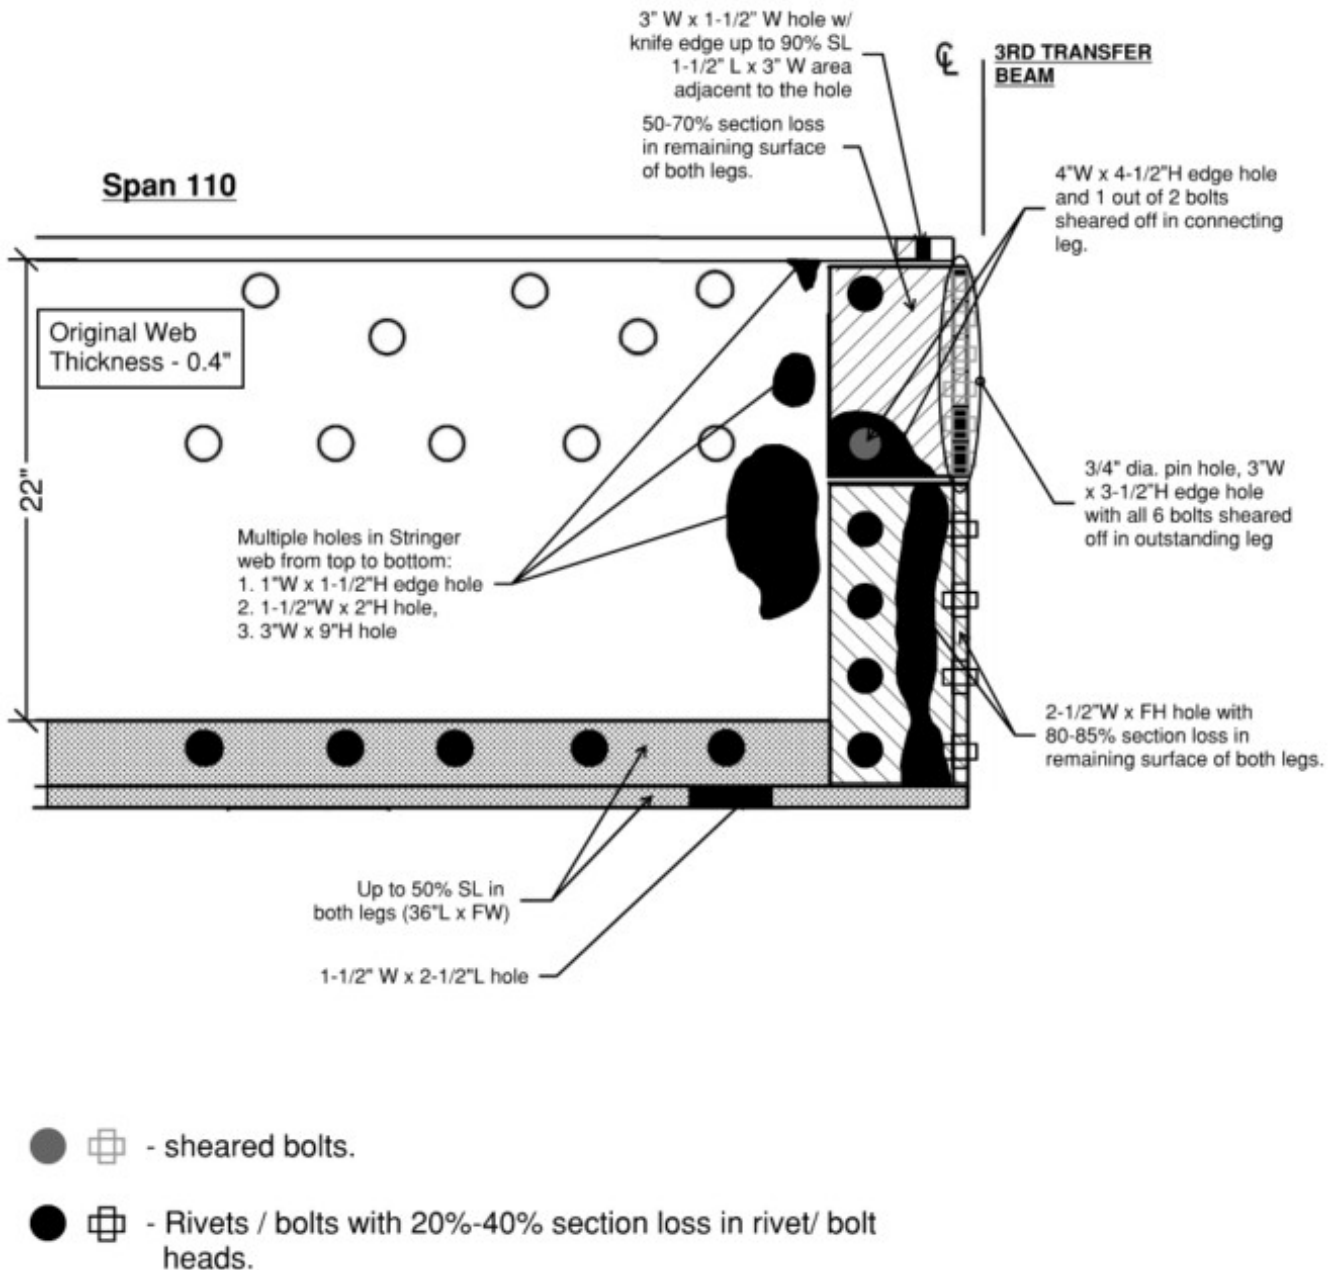
Photo Number: 2

Stringer S1 (WCG) web at end face of 3rd Transfer Beam:

- The stringer web exhibits a 1" W x 1-1/2" H edge hole along top flange, above the upper connection angle. There is also a 2"H x 1-1/2"W hole in stringer web adjacent to upper connection angle, located at 4-1/2" from top flange. Stringer S1 web also exhibits a large 3" W x 9" H hole at 8" from the top flange.

- The top flange exhibits 3" W x 1-1/2" W hole with knife edge up to 90% section loss over 1-1/2" L x 3" W area adjacent to the hole. The bottom flange angle on the left side of the stringer exhibits up to 50% section loss in both legs over an area of 36" L x full width. There is a 1-1/2" W x 2-1/2" L hole in bottom flange located at 8" from the stringer end.

- The stringer web has two connection angles on the left side. Upper connection angle has 2 out of 3 bolts sheared off in connecting leg and all 6 bolts sheared off in outstanding leg. Connecting leg of upper connection angle exhibits a 4"W x 4-1/2"H edge hole. Outstanding leg of connection angle exhibits one 3/4" dia. pin hole in upper side and a 3"W x 3-1/2"H edge hole in lower side of the leg. Remaining area of both legs exhibits 50-70% section loss. There is pack rust between outstanding leg and railing post cover plate, causing up to 1" gap between two surfaces.

- Lower connection angle exhibits a 2-1/2" W x full height hole in connecting leg. Remaining surface of both legs exhibits 80-85% section loss.
- Connection angle on right side of the stringer web exhibits heavy pack rust in top part of connecting leg, causing up to 2" bulging of connecting leg. In addition, there is a 38"L x 2-1/2"W hole in the curb plate along the right side of the top flange.

SKETCH FOR YELLOW FLAG # NB23U4W007
SPAN 110, STRINGER S1
AT END FACE OF 3RD TRANSFER BEAM
(LOOKING RIGHT)
N.T.S

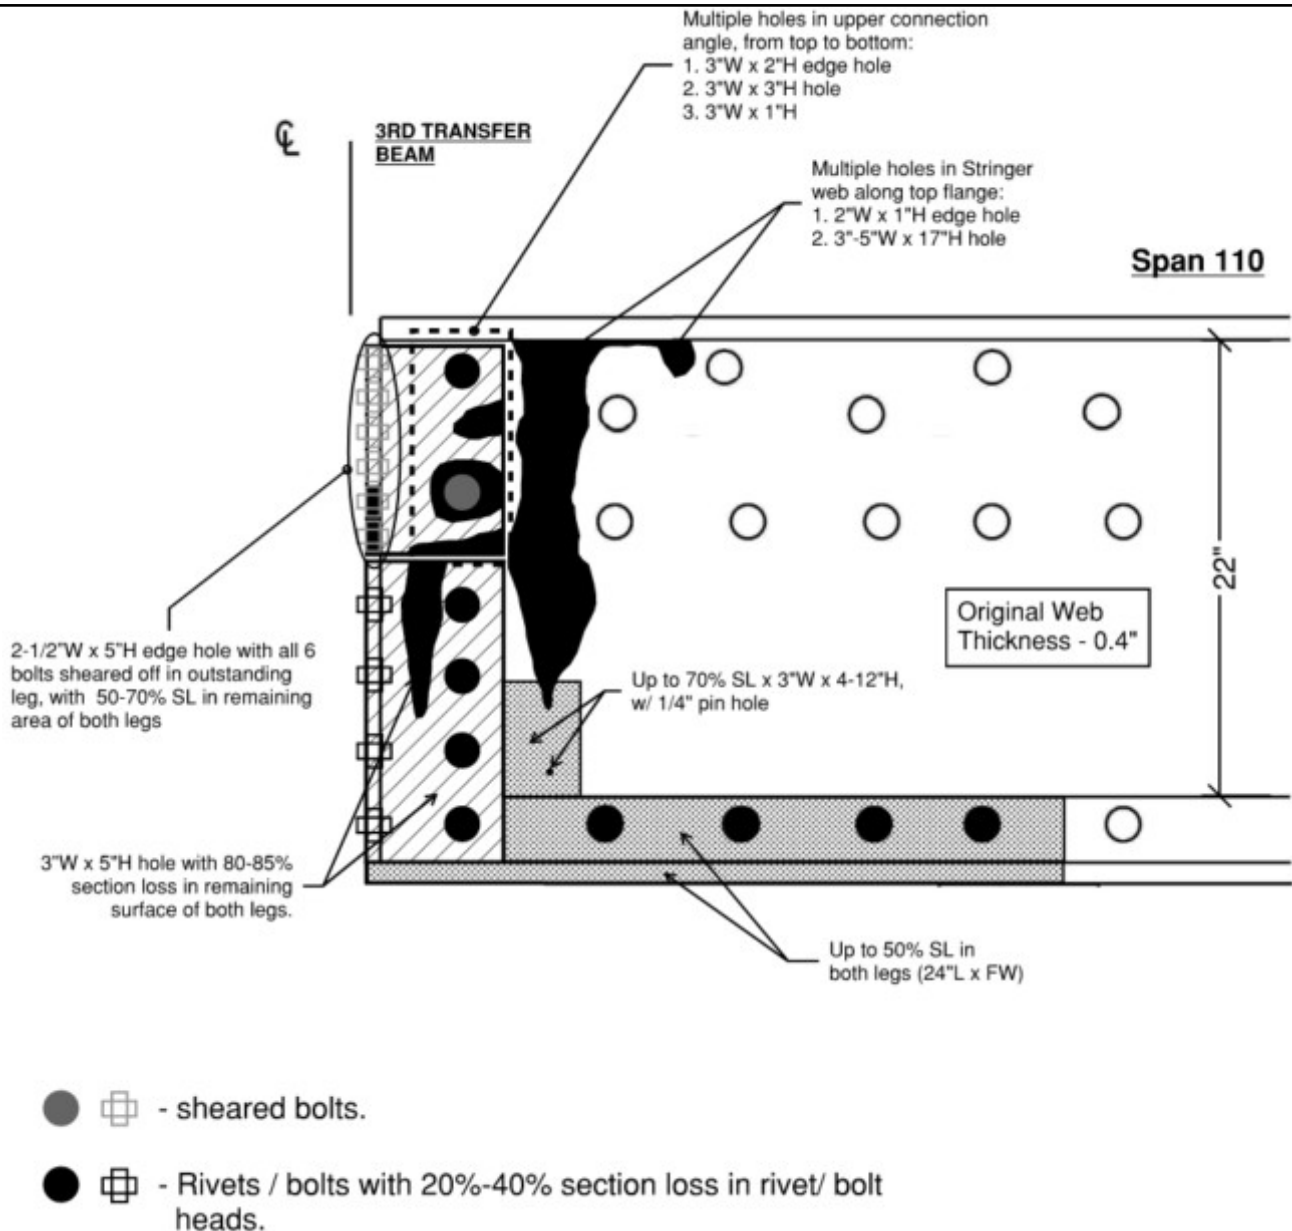
Photo Number: 3

Stringer S1 (WCG) web at begin face of 3rd Transfer Beam:

- The stringer web exhibits a 2" W x 1" H edge hole along the top flange, at 6" from the upper connection angle. There is a 3"-5" W x 17" H hole in the stringer web along the connection angle. Stringer web also exhibits up to 70% section loss over a 4-1/2" H x 3" W area with one 1/4" dia. pin hole along bottom flange connection angle.

- The bottom flange angle on the left side of the stringer exhibits up to 50% section loss in both legs over an area of 24" L x full width.
- The stringer web has two connection angles on the left side of the stringer. The upper connection angle has 2 out of 3 bolts sheared off in the connecting leg and all 6 bolts sheared off in the outstanding leg. Connecting leg of upper connection angle exhibits 3 edge holes (2"H x 3" W), (3"H x 3" W) and (1"H x 3" W). The outstanding leg of the upper connection angle exhibits 5"H x 2-1/2" W edge hole in lower side of the leg. Remaining area of both legs exhibits 50-70% section loss. There is pack rust between the outstanding leg and railing post cover plate, causing up to 1" gap between the two surfaces.

- The lower connection angle exhibits a 3"W x 5"H edge hole on the upper side of connecting leg. Remaining surface of the connecting leg exhibits 80-85% section loss.

- Connection angle on right side of the stringer web exhibits heavy pack rust in top part of connecting leg, causing up to 2" bulging of connecting leg. In addition, there is a 5"L x 2-1/2"W hole in the curb plate above, along the right side of the top flange of Stringer S1.

SKETCH FOR YELLOW FLAG # NB23U4W007
SPAN 110, STRINGER S1
AT BEGIN FACE OF 3RD TRANSFER BEAM
(LOOKING RIGHT)
N.T.S

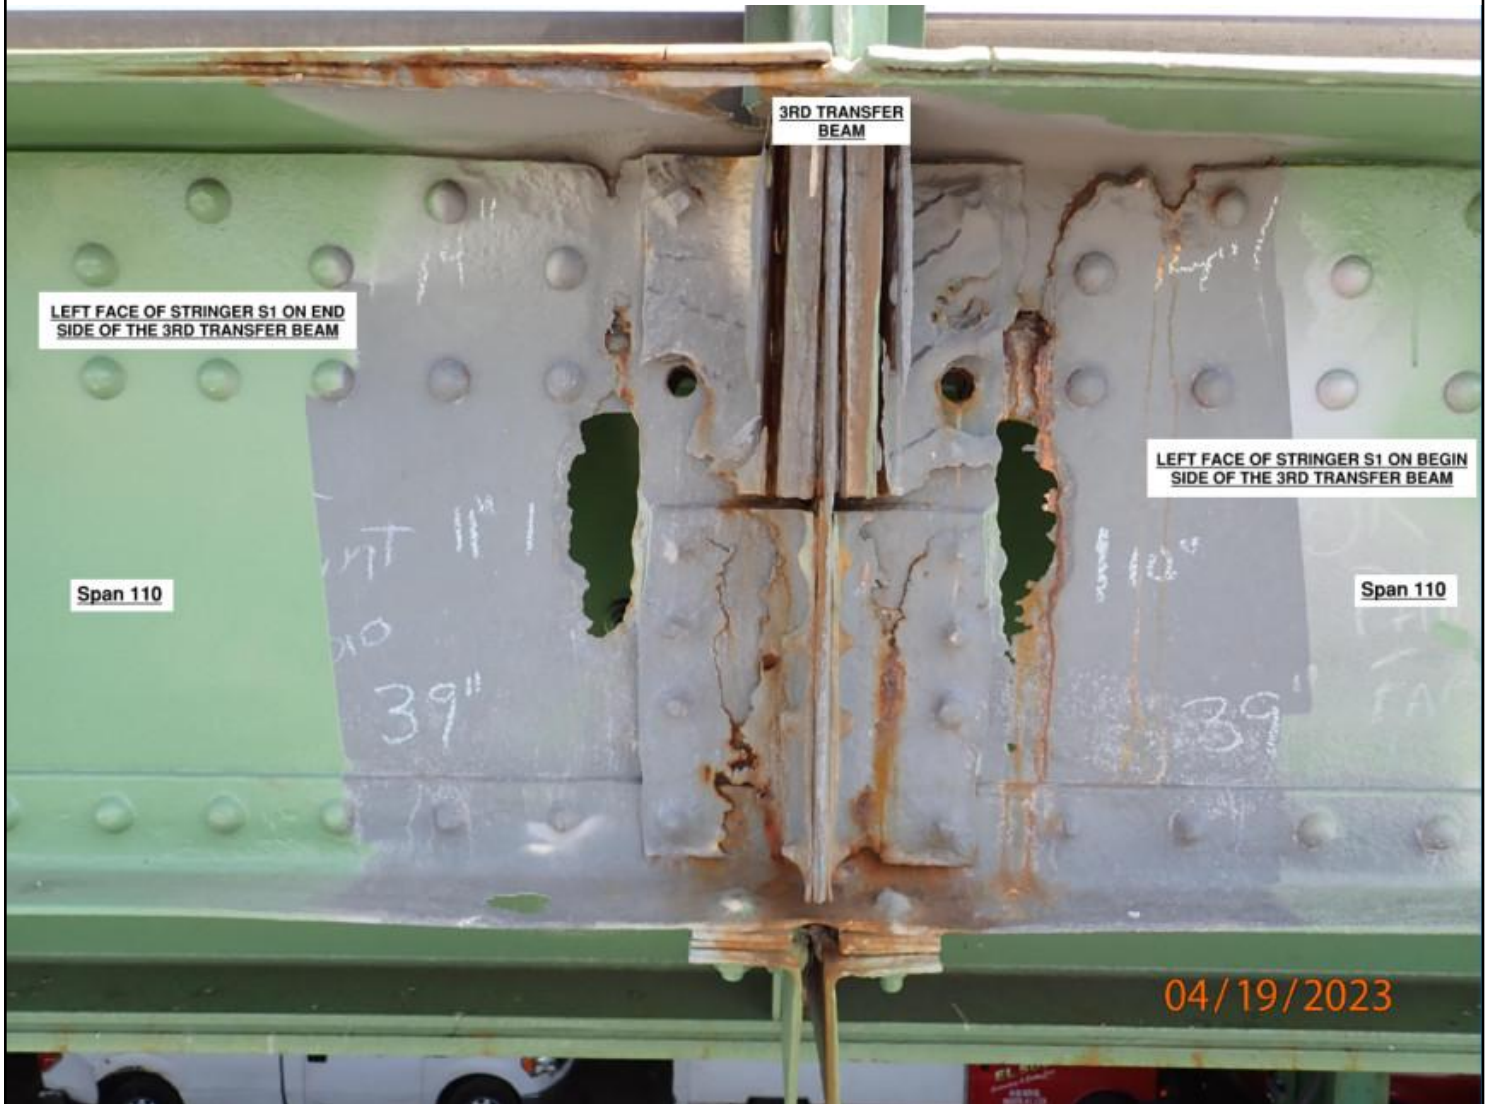
Photo Number: 4

This condition is observed in the web of Stringer S1 [West Curb Girder – (WCG)] at the connection angle on both sides of the 3rd transfer beam near the center of the span. Stringer S1 on both sides of the Transfer Beam 3 has multiple large corrosion holes in the stringer web, adjacent to/alongside the connection angle to the transfer beam. (Photo 4).

Attachment Description: General View of S1 at 3rd Transfer beam in Span 110. Multiple holes and missing connection bolt in upper connection angle, stringer web and top flange with section loss in surrounding area. Looking Right.

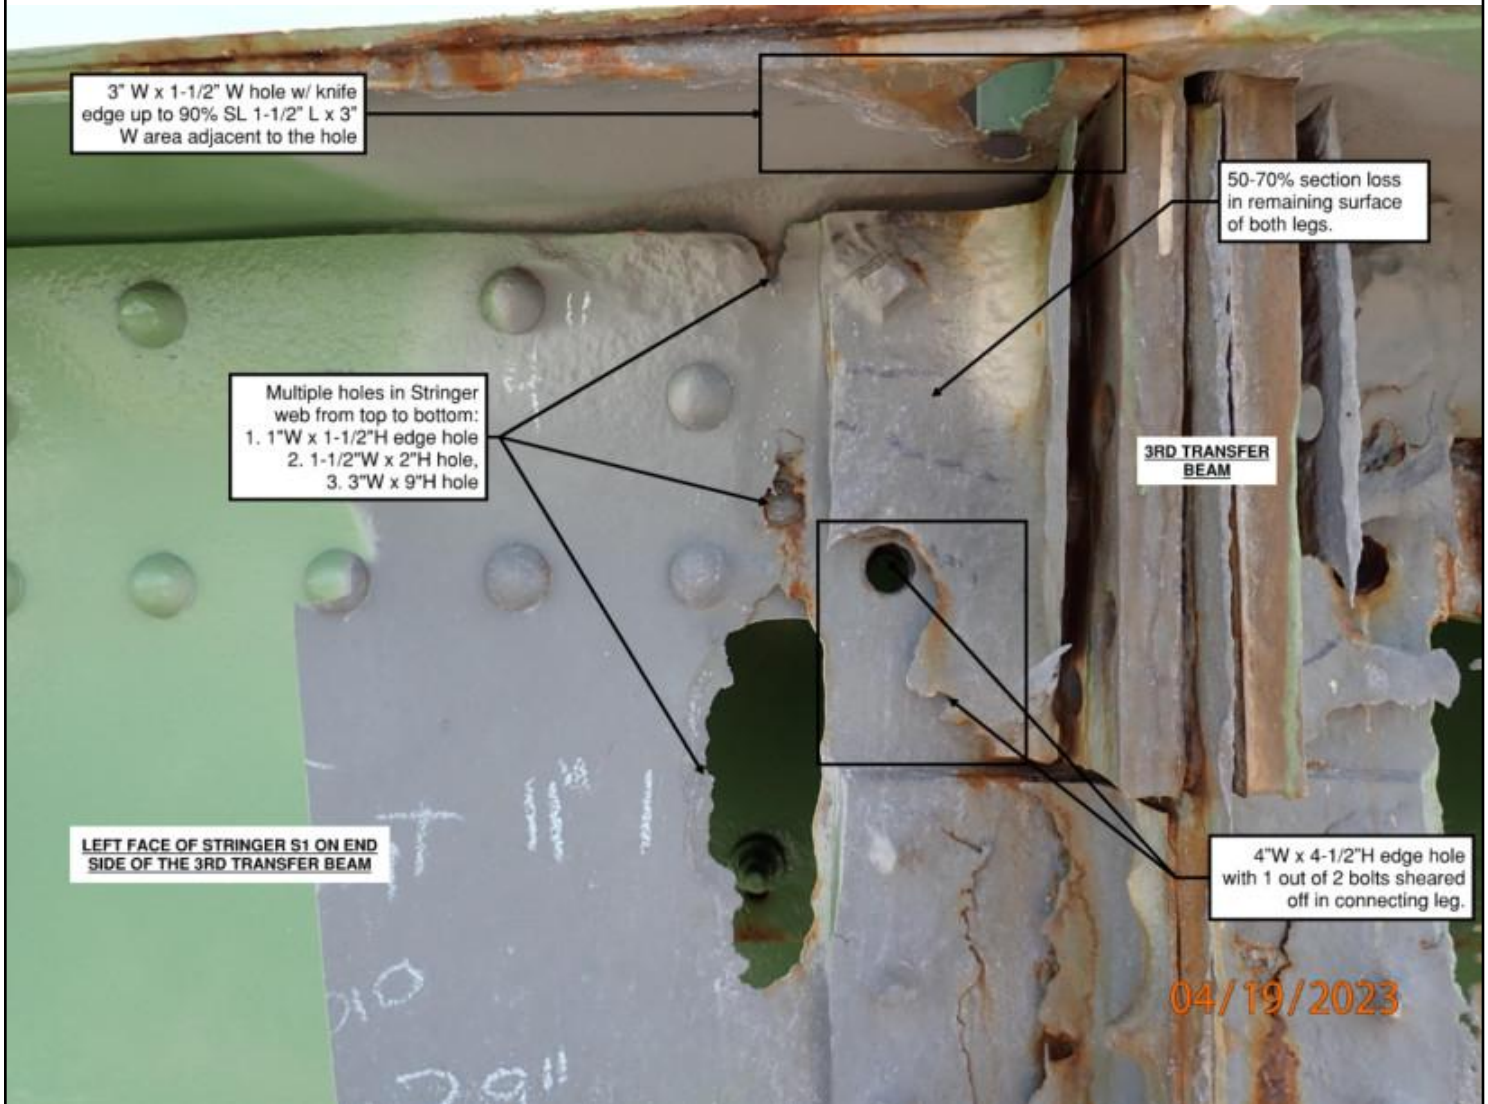
Photo Number: 5

Attachment Description: Multiple holes and missing connection bolt in upper connection angle, stringer web and top flange with section loss in surrounding area. Looking Right.

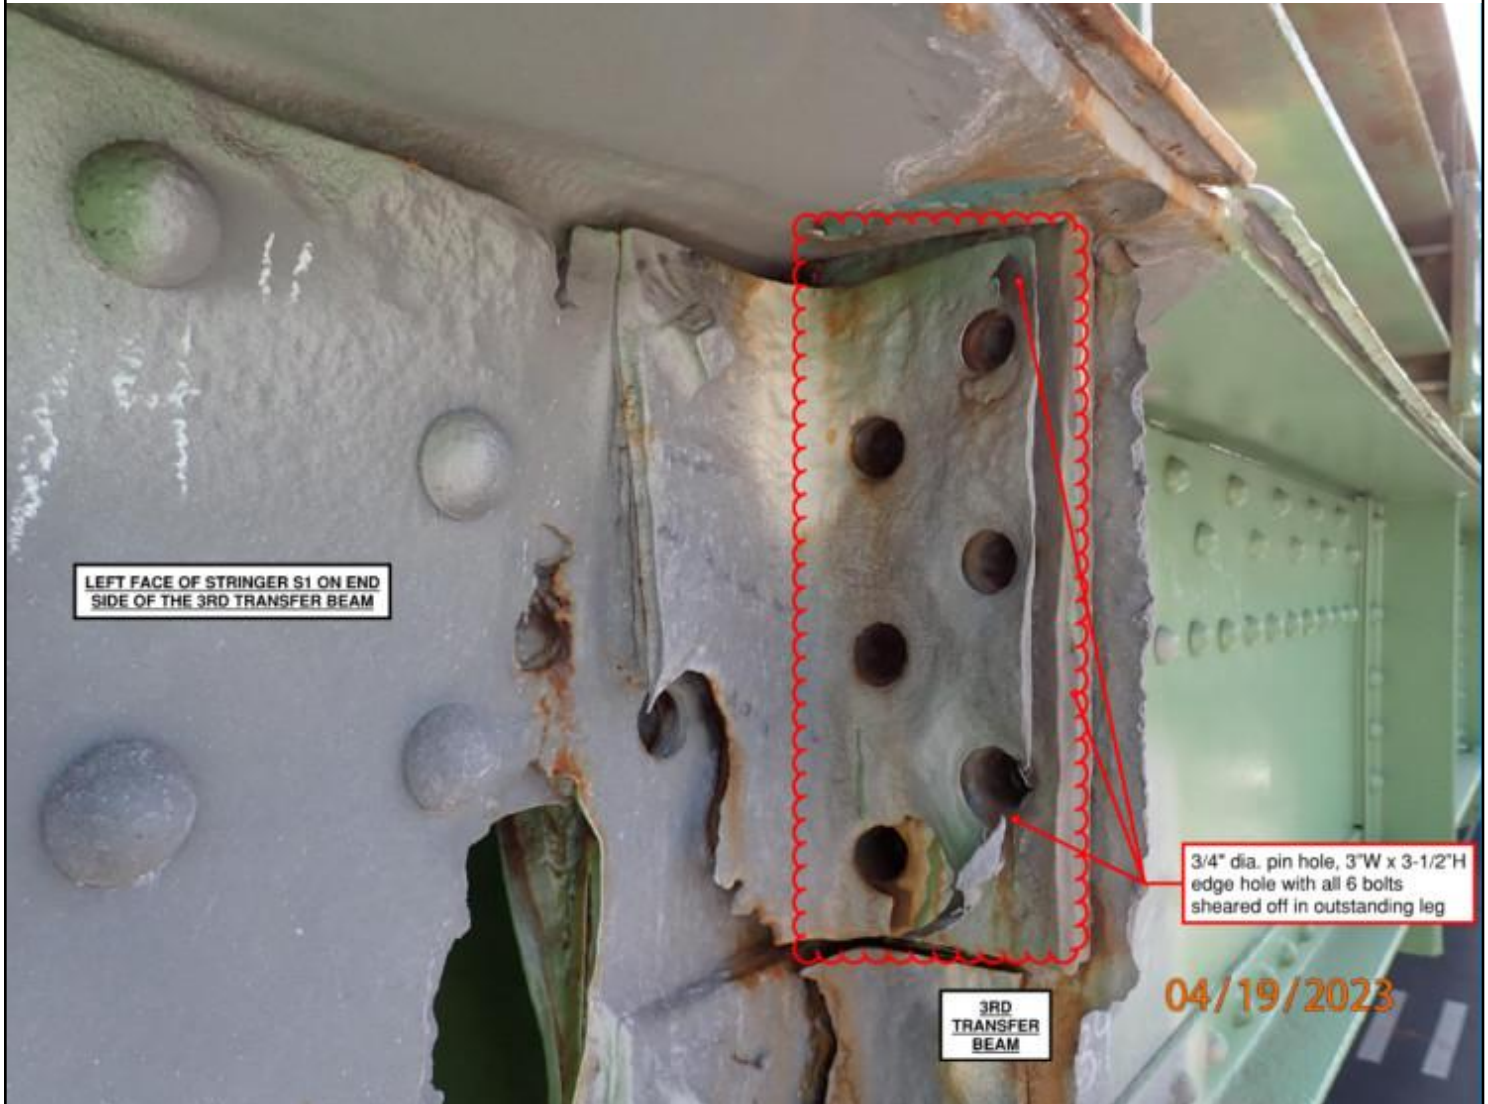
Photo Number: 6

Attachment Description: 3/4" dia. pin hole, 3"W x 3-1/2"H edge hole with all 6 bolts sheared off in outstanding leg of upper connection angle. Looking Begin - Right.

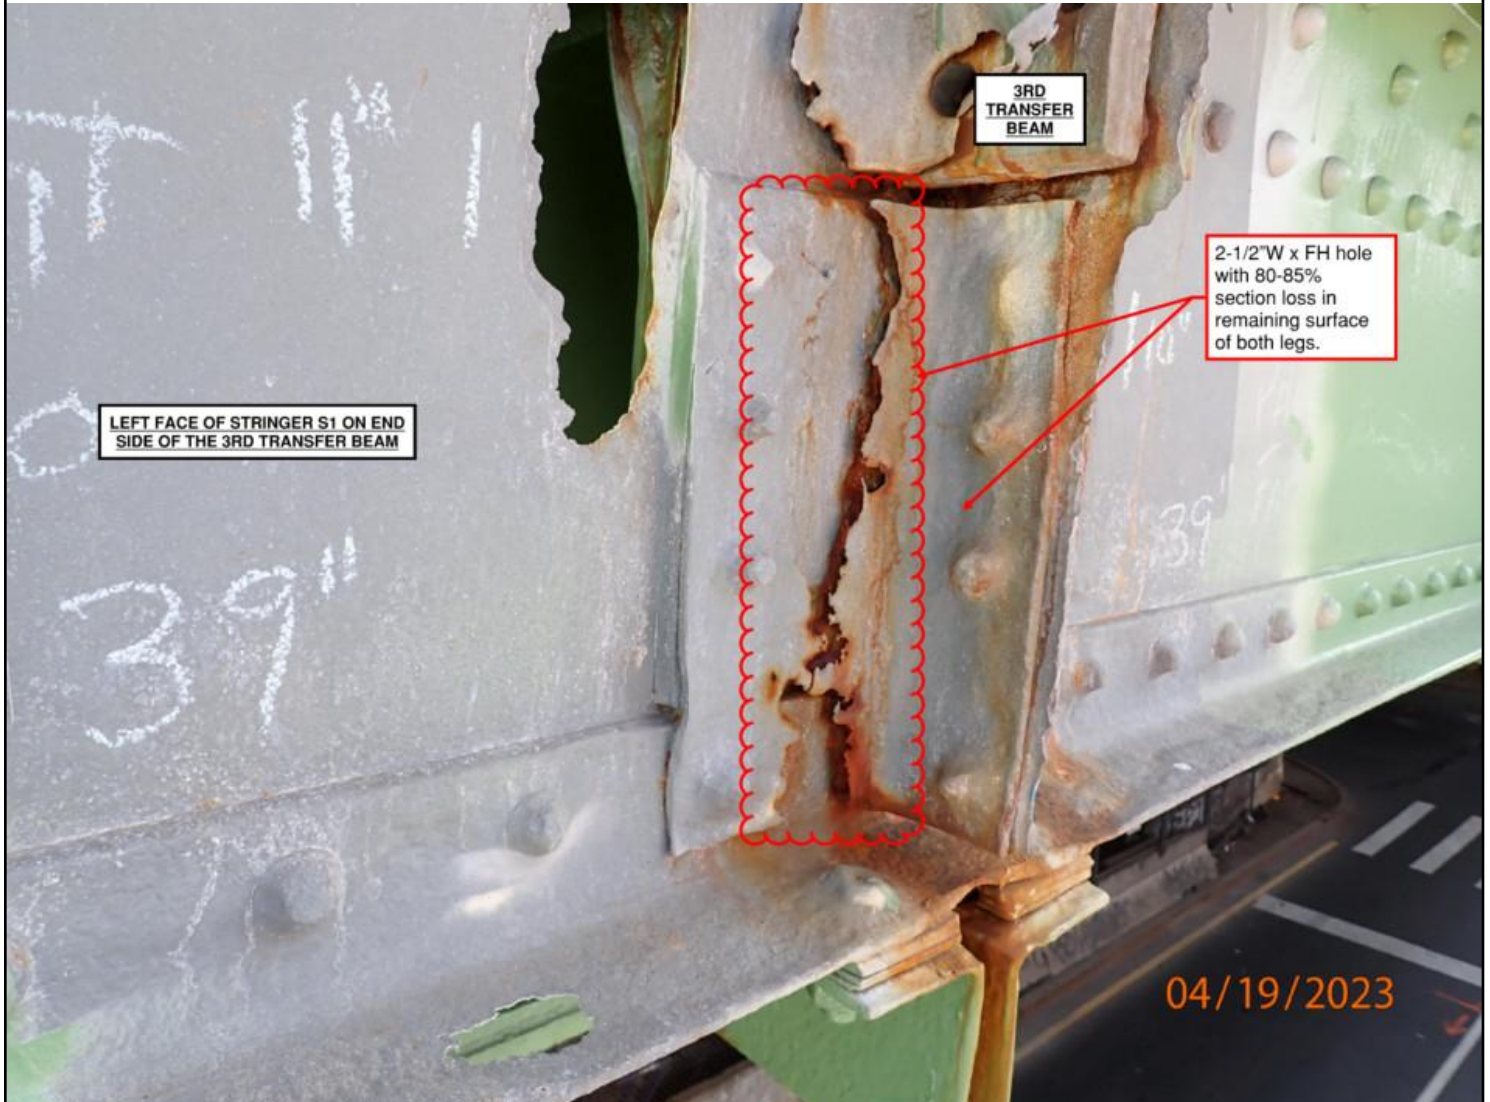
Photo Number: 7

Attachment Description: 2-1/2"W x FH hole in connecting leg with 80-85% section loss in remaining surface of both legs. Looking Begin - Right.

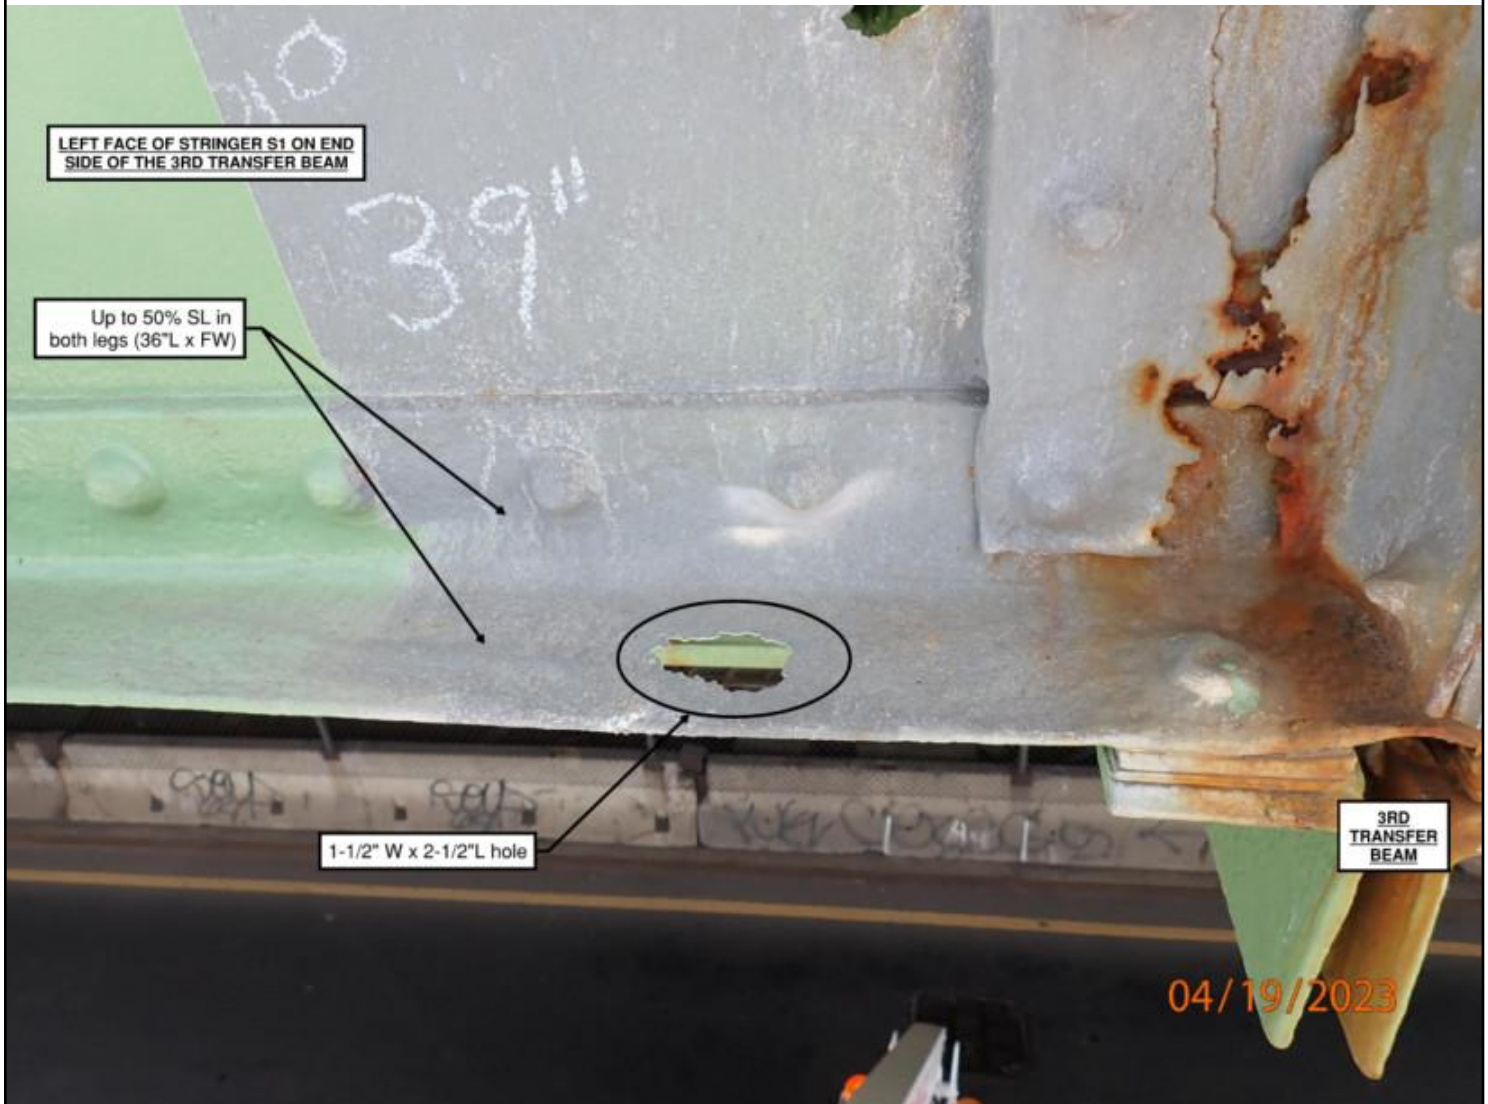
Photo Number: 8

Attachment Description: Up to 50% SL in both legs (36"L x FW) with a 1-1/2" W x 2-1/2"L hole in outstanding leg of left side bottom flange angle. Looking Right - Down.

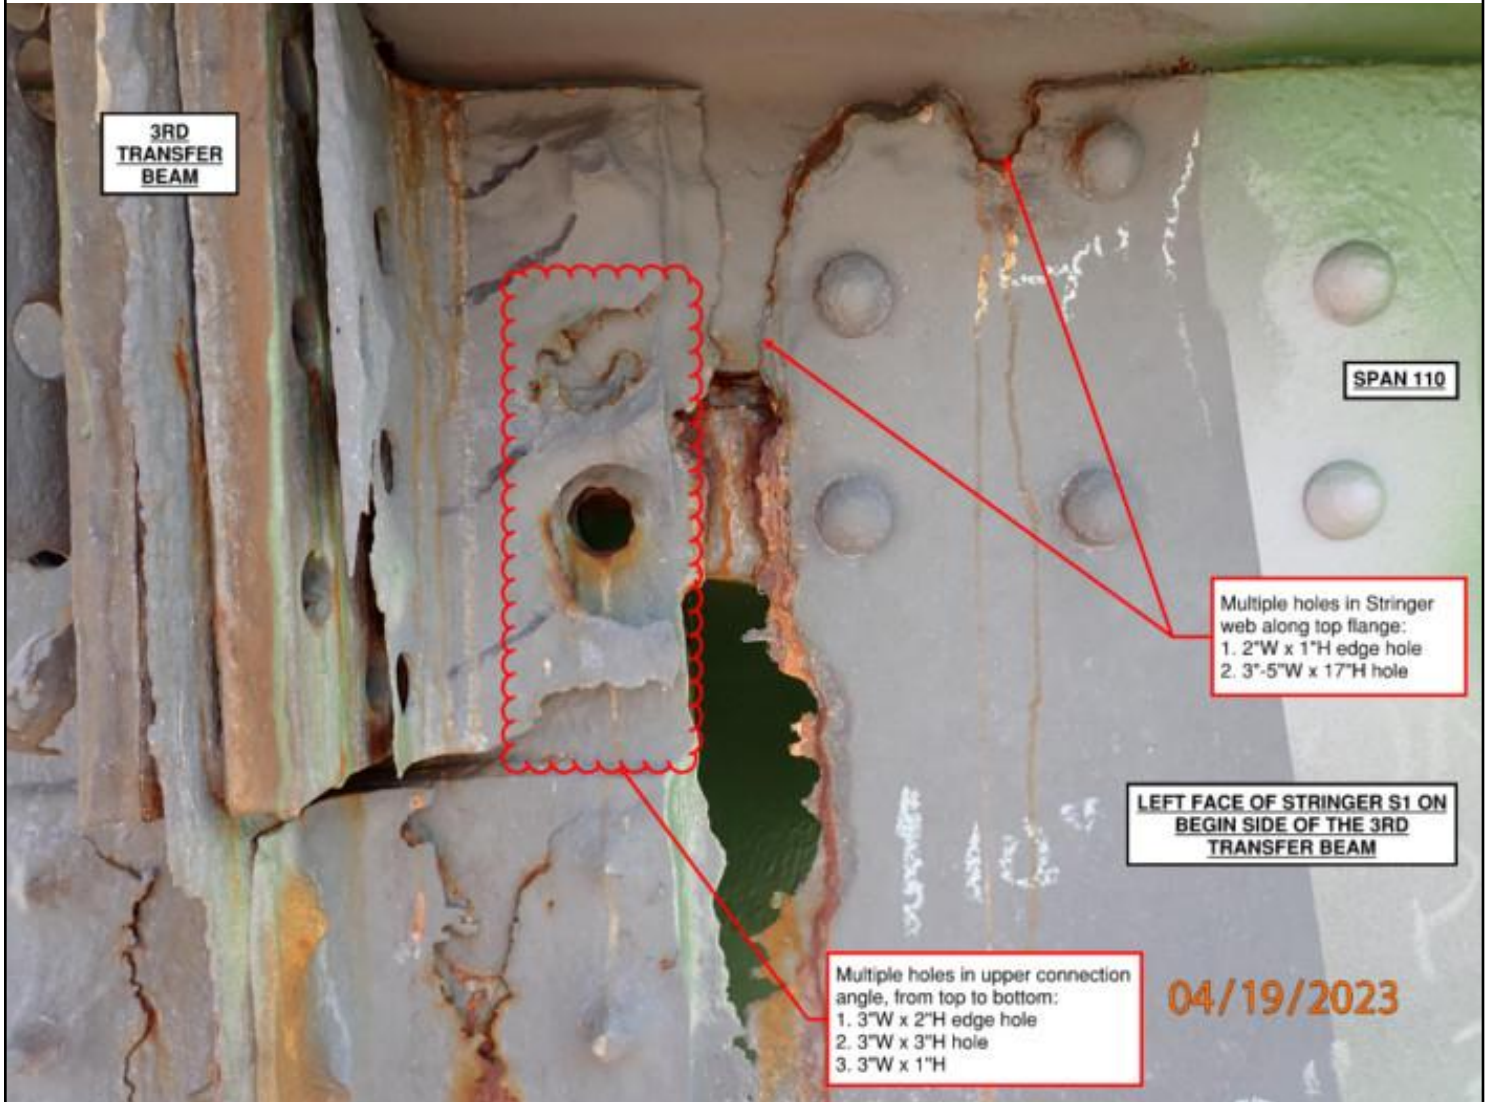
Photo Number: 9

Attachment Description: Multiple holes with missing connection bolt in upper connection angle, stringer web and top flange with section loss in surrounding area. Looking Right.

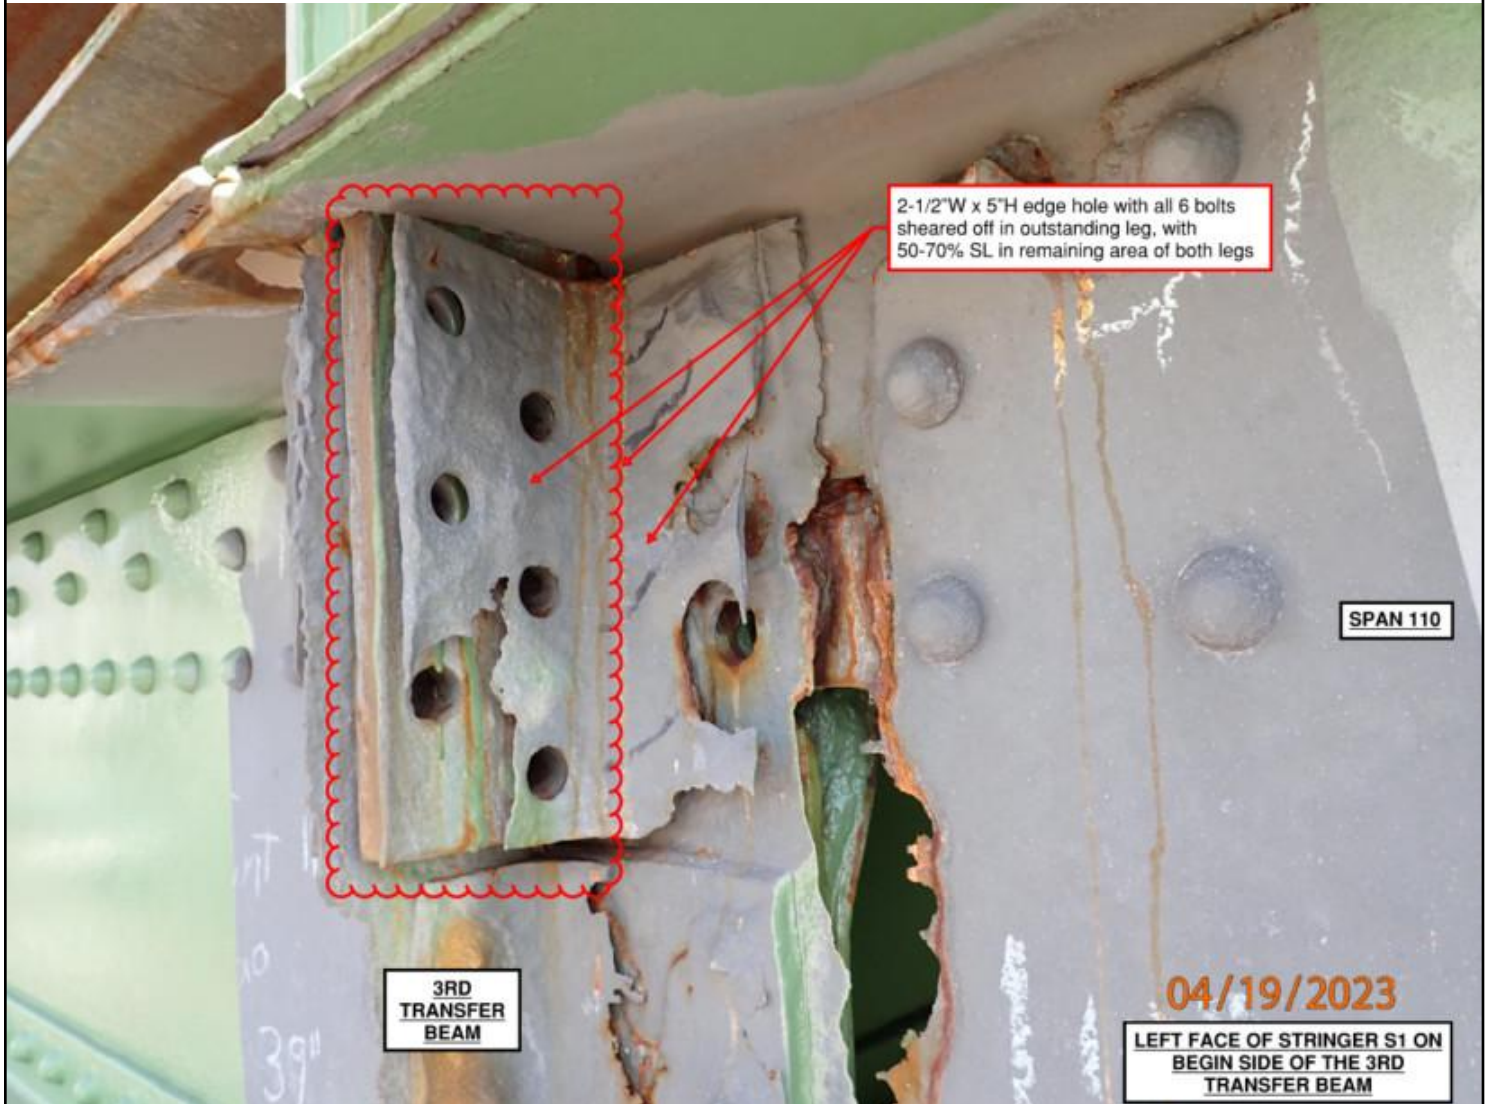
Photo Number: 10

Attachment Description: 2-1/2"W x 5"H edge hole with all 6 bolts sheared off in outstanding leg, with 50-70% SL in remaining area of both legs of upper connection angle. Looking End - Right.

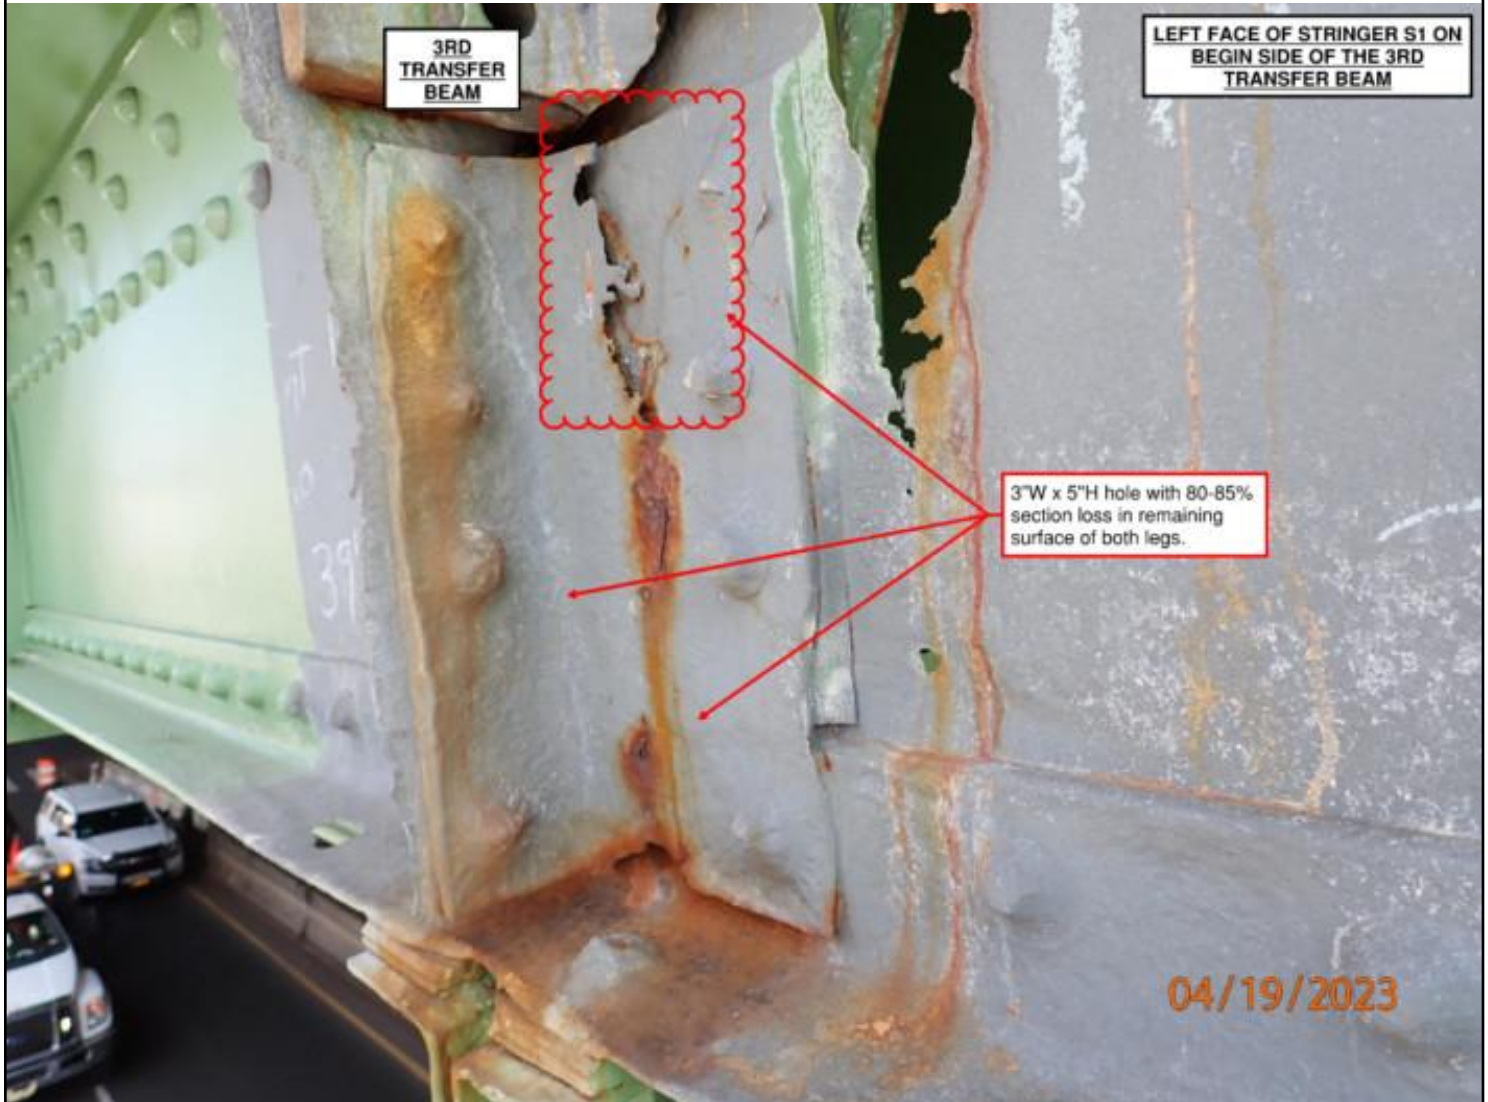
Photo Number: 11

Attachment Description: 3"W x 5"H hole in connecting leg with 80-85% section loss in remaining surface of both legs of lower connection angle. Looking End - Right.

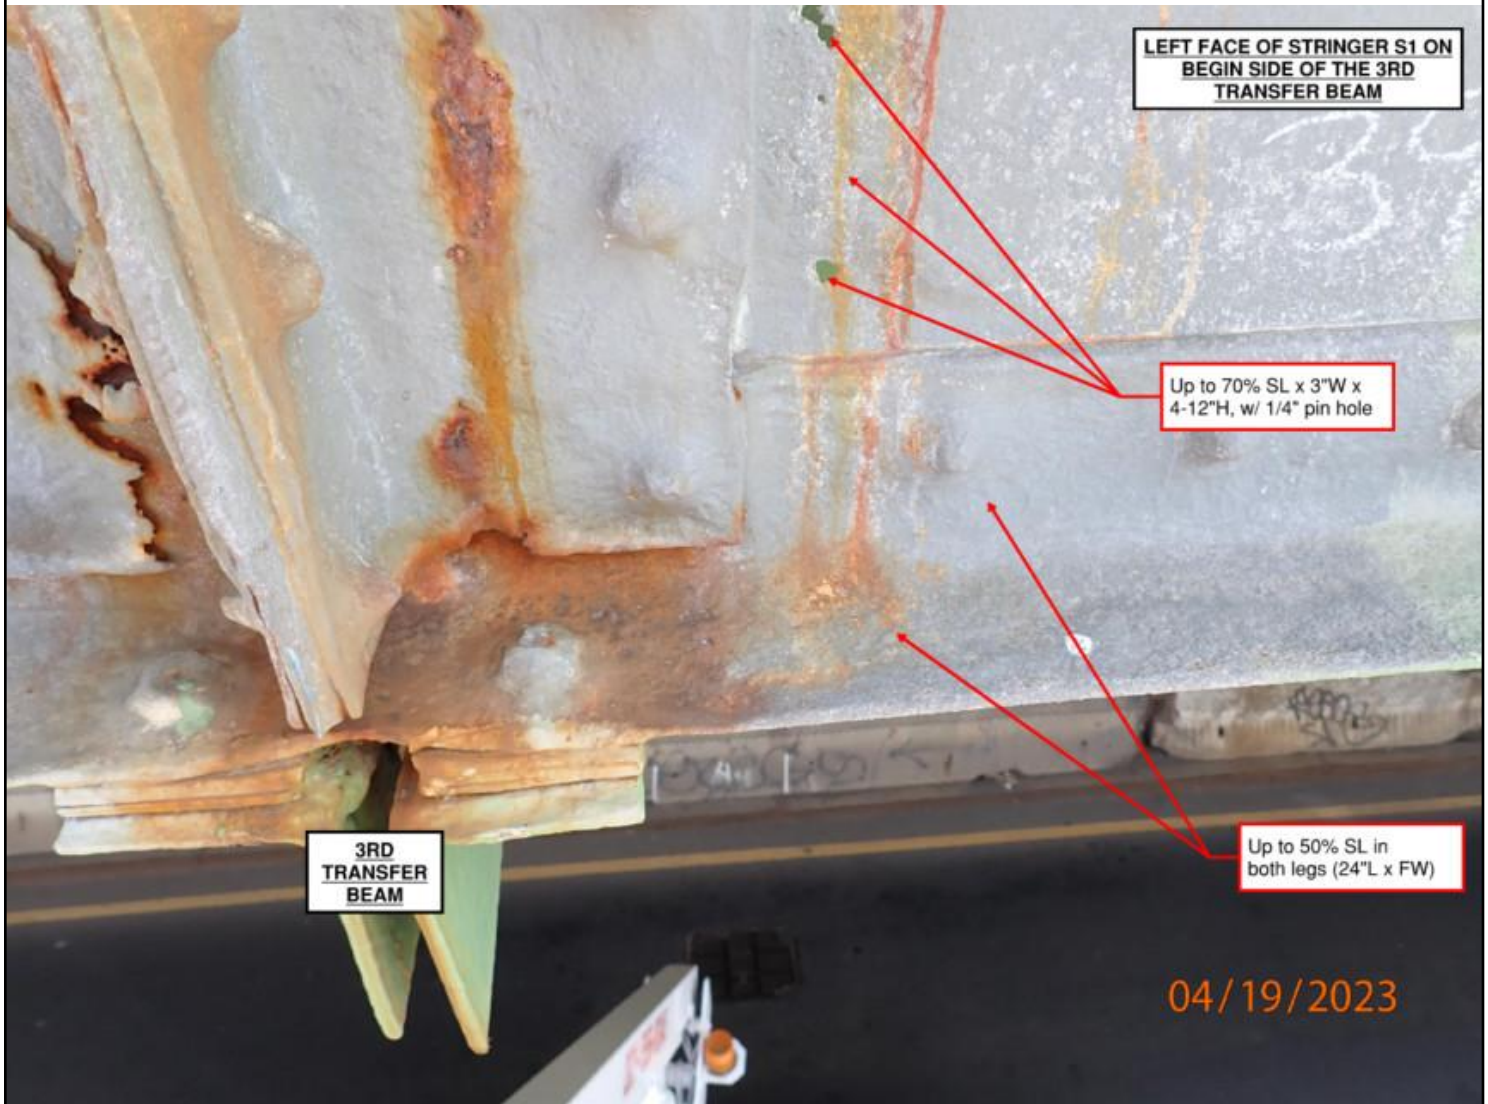
Photo Number: 12

Attachment Description: Stringer web exhibits up to 70% SL x 3"W x 4-12"H, w/ 1/4" pin hole in lower web along bottom flange angle. Bottom flange angle on left side has up to 50% SL (24"L x FW) in both legs. Looking Right - Down.
